NASA TM -86529

COMPUTED TOMOGRAPHY FOR NON-DESTRUCTIVE EVALUATION OF COMPOSITES: APPLICATIONS AND CORRELATIONS

By B. Goldberg, L. Hediger, and E. Noel

Materials and Processes Laboratory
Science and Engineering Directorate

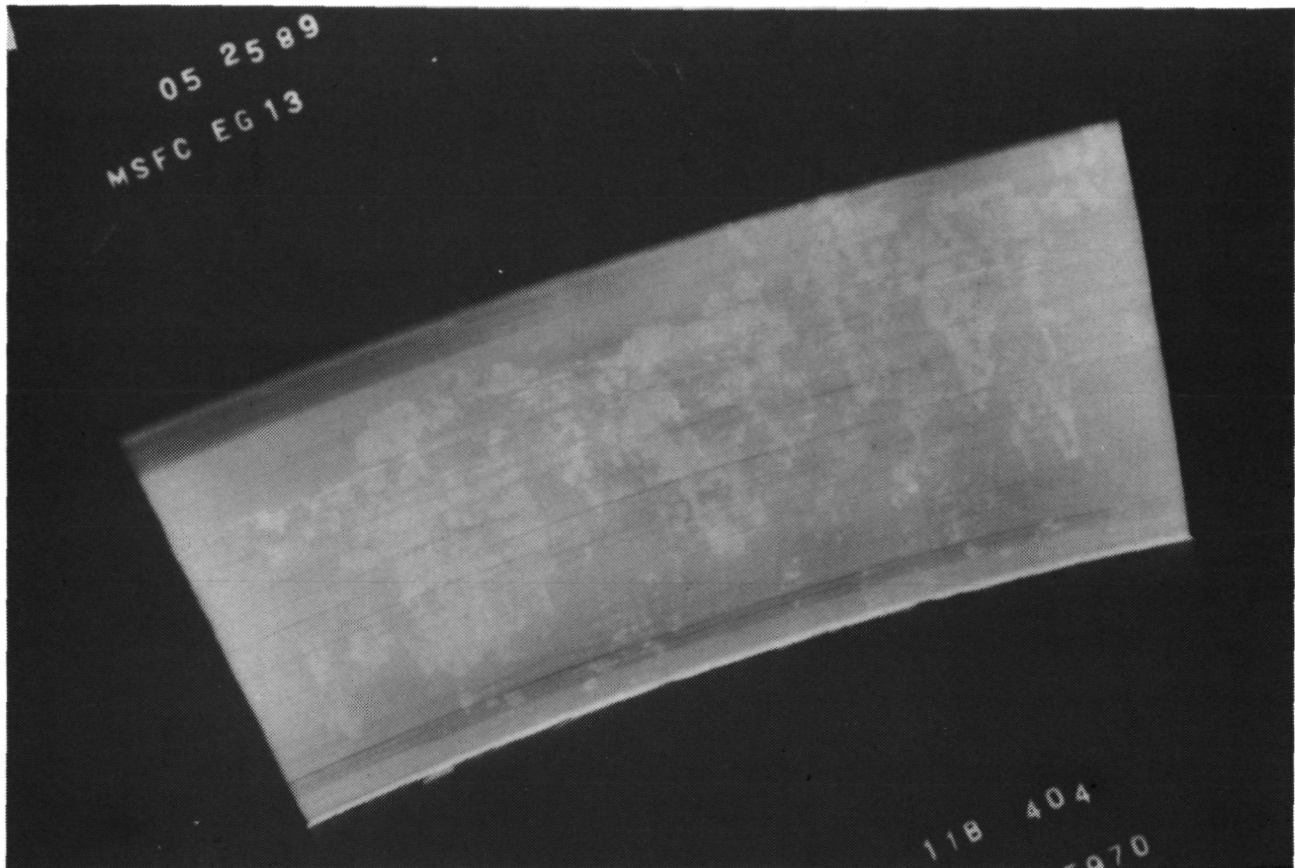
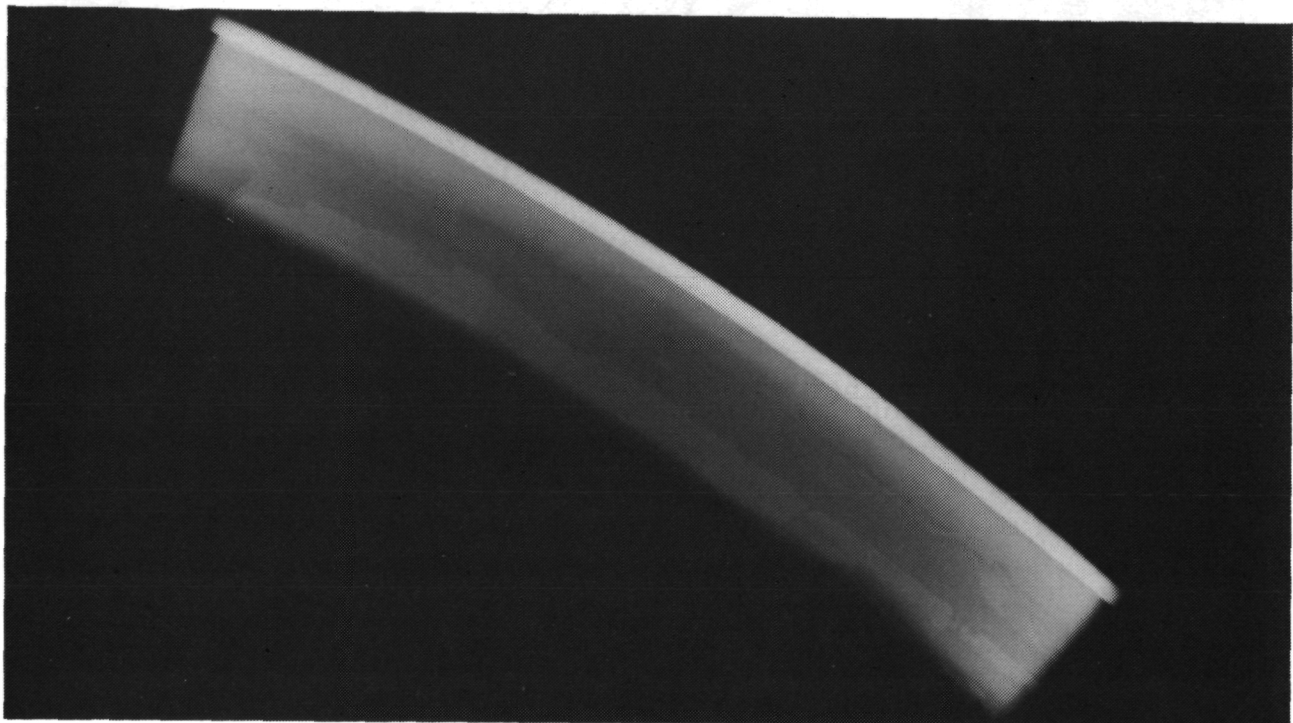
delaminations noted through the visual inspection (Fig. 25). Thermal cracking was evident in two of the fired segments. Cloth-to-cloth lacing patterns were visible in one of the fired segments. Tangential radiographs of the fired segments also indicated that the char/erosion profile ranged from 20 percent (in the thickest segment) to 100 percent (thinnest segment). More subtle anomalies may have been masked by these conditions. The complex geometry of char and erosion patterns prohibited successful ultrasonic inspection.

Figure 25. Radiography of fired SRM samples. (a) Radial view. Note char and erosion pockets, delaminations, and cloth patterns. (b) Tangential view. Dark, low-density region on ID reflects char zone. Variable density indications through segment are artifacts due to rubber insulator material on base. (See Figure 24.)

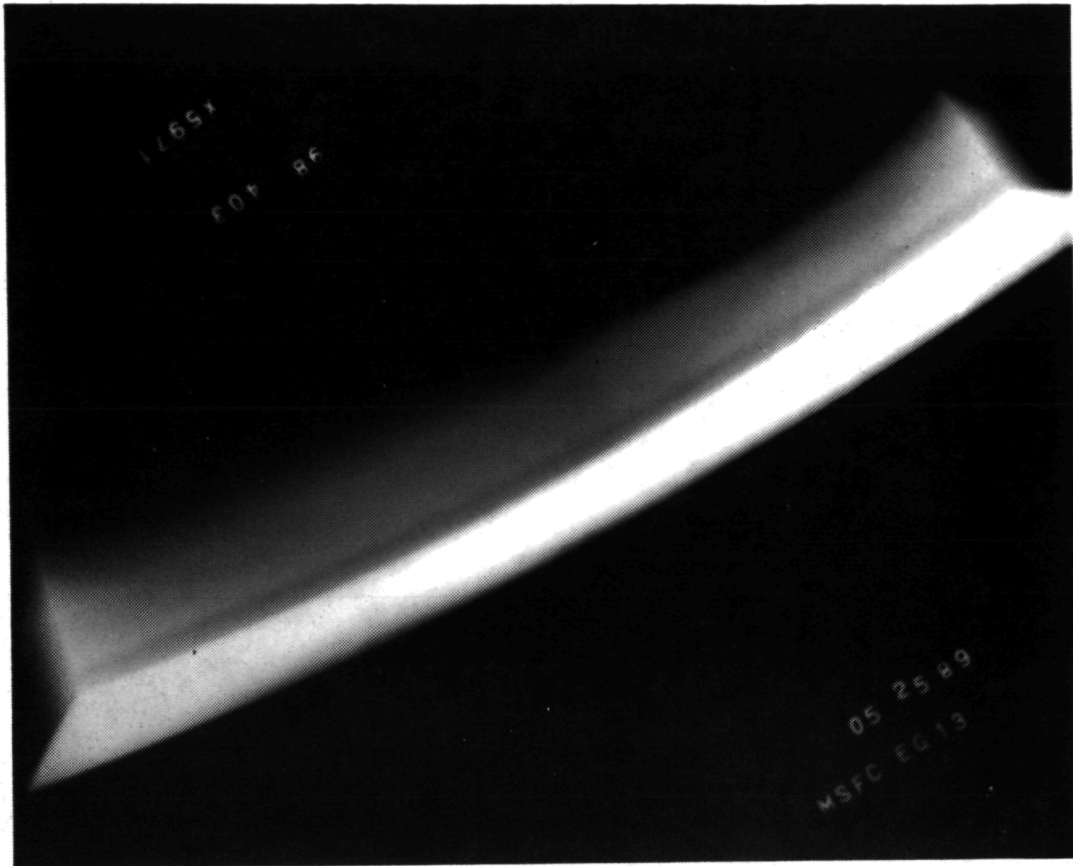
Figure 27. RT of unfired SRM sample/true tangential. (a) initial tangential view reflects ply superpositioning effects through anomalous density variability and diminished resolution. (b) True tangential view shows improved contrast and reduction of ply superpositioning effects.

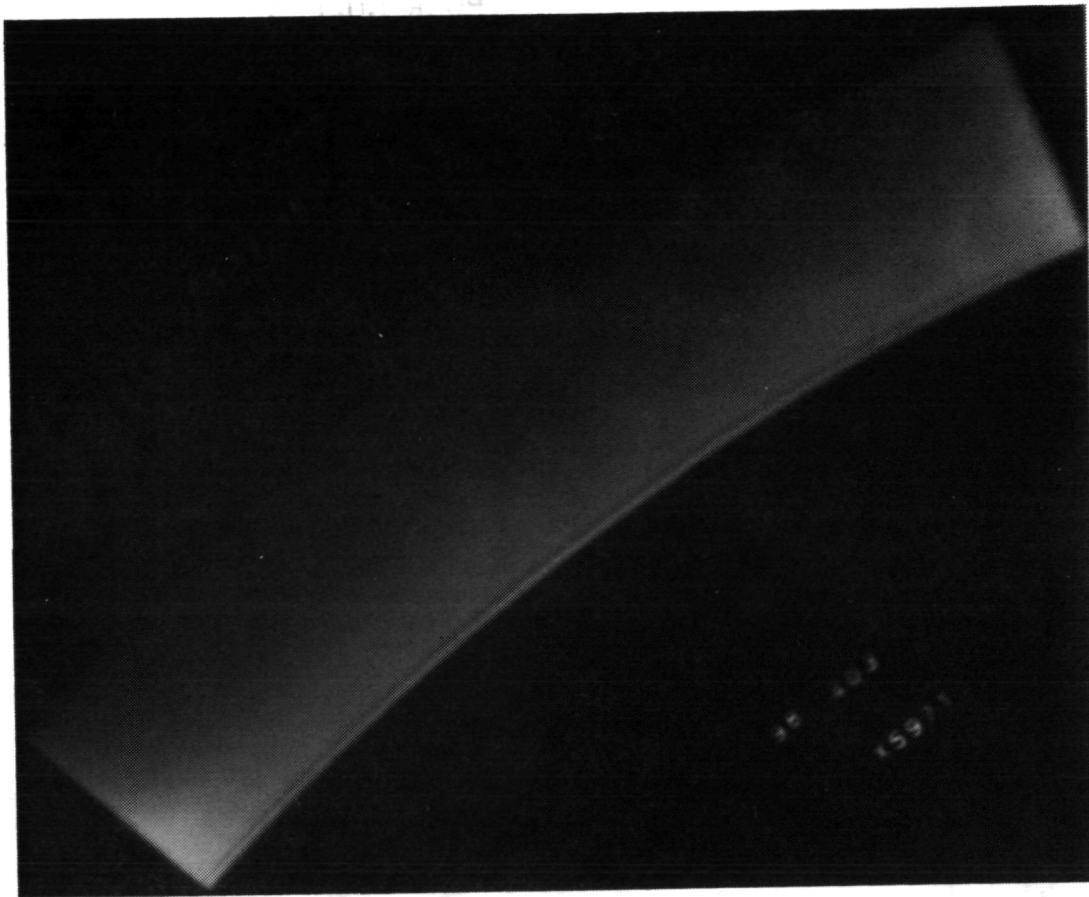
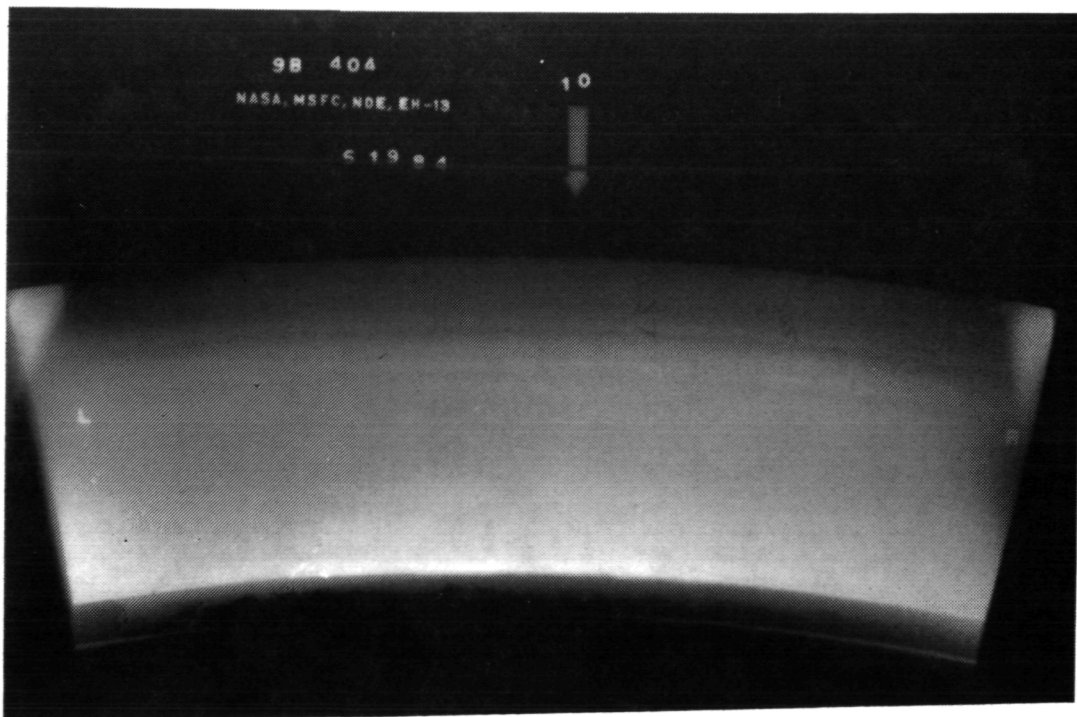
Figure 28. RT of unfired SRM samples/radial. (a) Note internal density variations, cloth patterns, and cloth-to-cloth lacing patterns.
(b) Note delaminations, resin-starved regions, and cloth patterns.

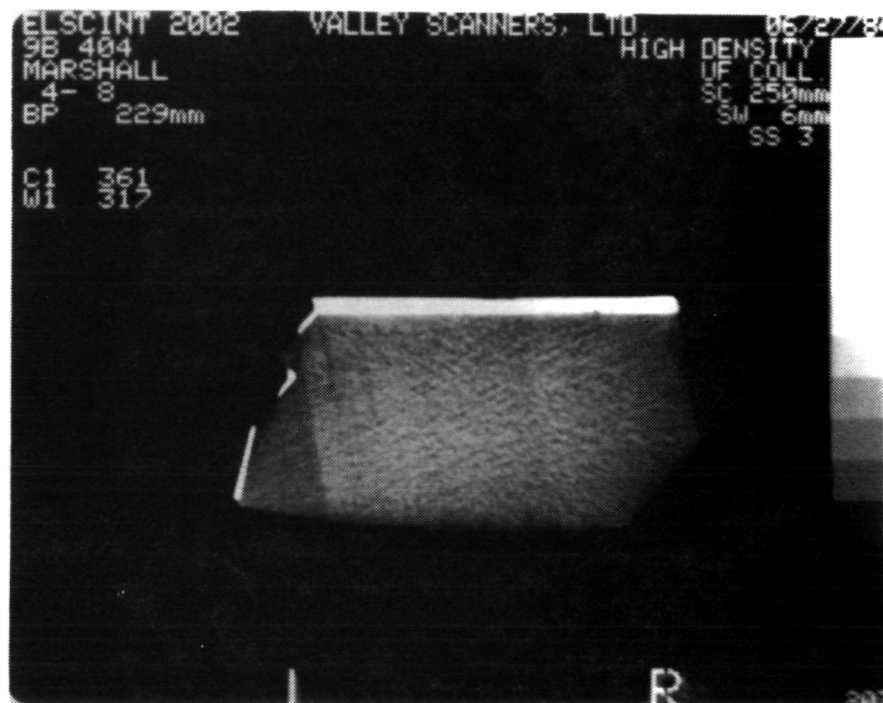
Figure 30. CT of unfired SRM sample/tangential. (Dark band on left side of image may result from cure cycle variations. Delaminations and resin-starved regions also appear.)

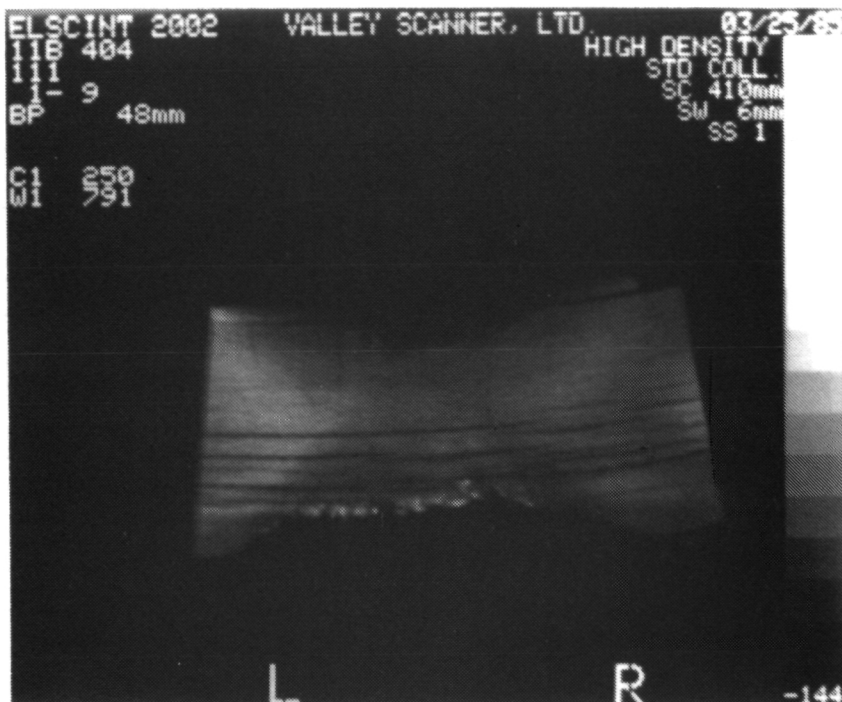
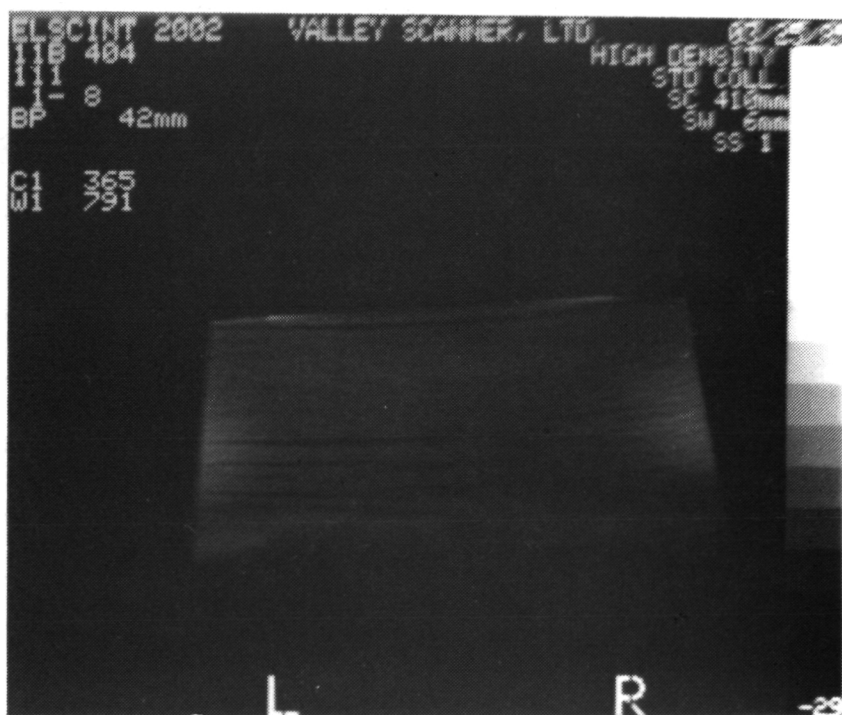
Figure 31. CT of fired SRM sample/axial. (a) Char/erosion patterns and delaminations are visible in the segment. (b) Further into the sample, delaminations still appear. Char/erosion patterns are less apparent.

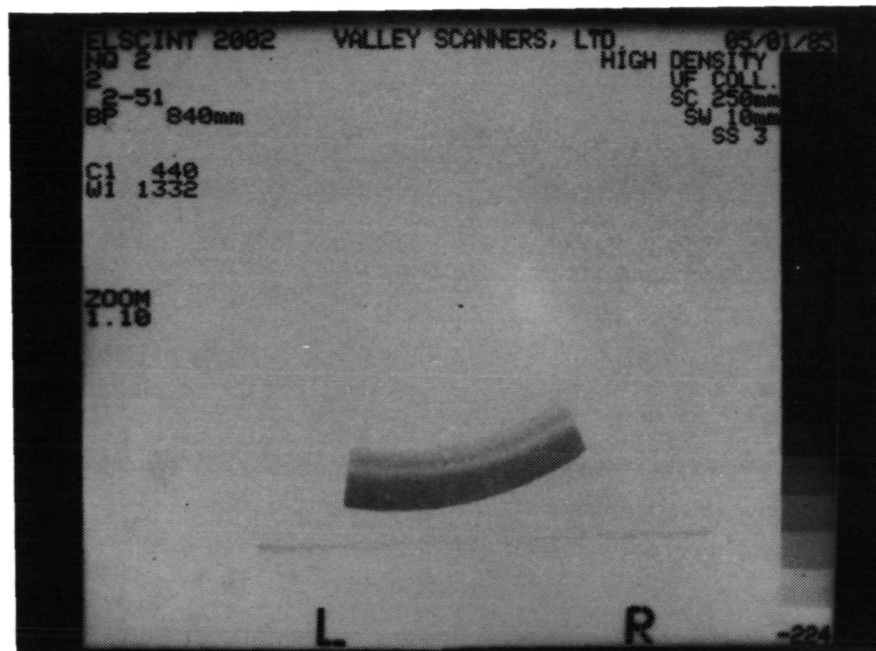
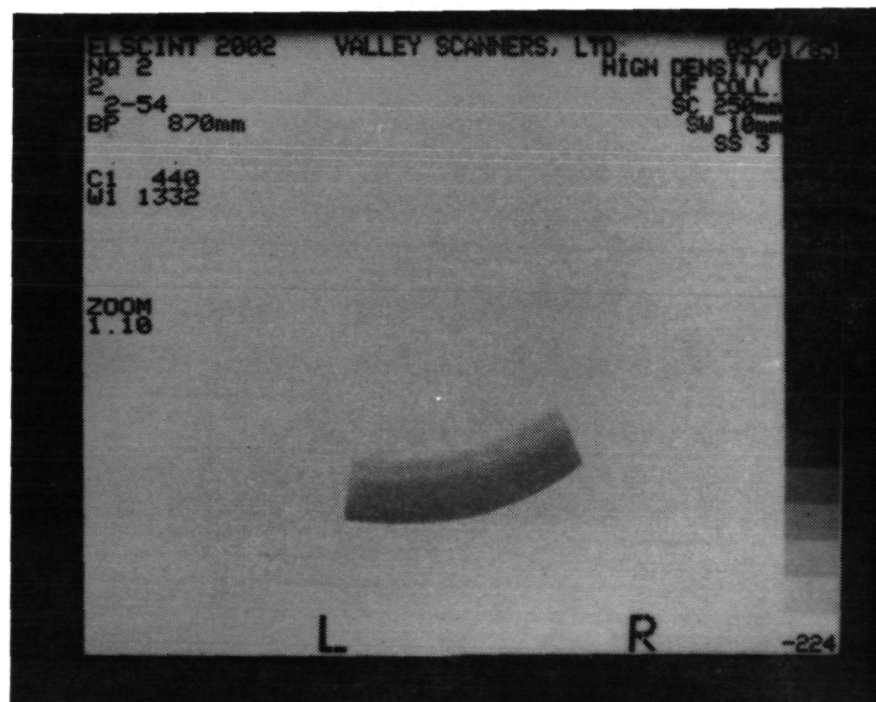
Figure 32. CT of NQ2/forward section. (a) Char/heat-affected regions are delineated by minimum density regions. (b) Identical to (a). Note clarity of char profile.

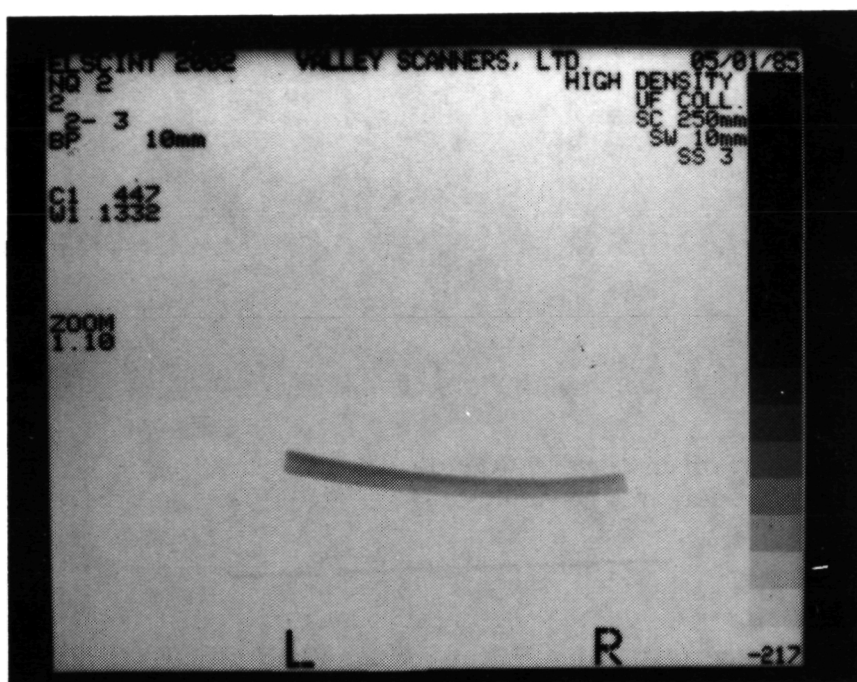
Figure 33. CT of NQ2/aft section. Char profile remains visible.
Mapping subjectivity, even in thin regions, is clearly reduced.
